The Use of Sand Fences in Barrier Island Restoration: Experience on the Louisiana Coast

By Syed M. Khalil

PURPOSE: This System-Wide Water Resources (SWWRP) technical note describes experiences with sand fences to reduce losses by wind-blown sand transport on restored barrier islands in Louisiana. Seven installations of sand fences with various plan view orientations and cross-sectional designs are reviewed. Recommendations are given for use of sand fences in conjunction with restoration of barrier island systems.

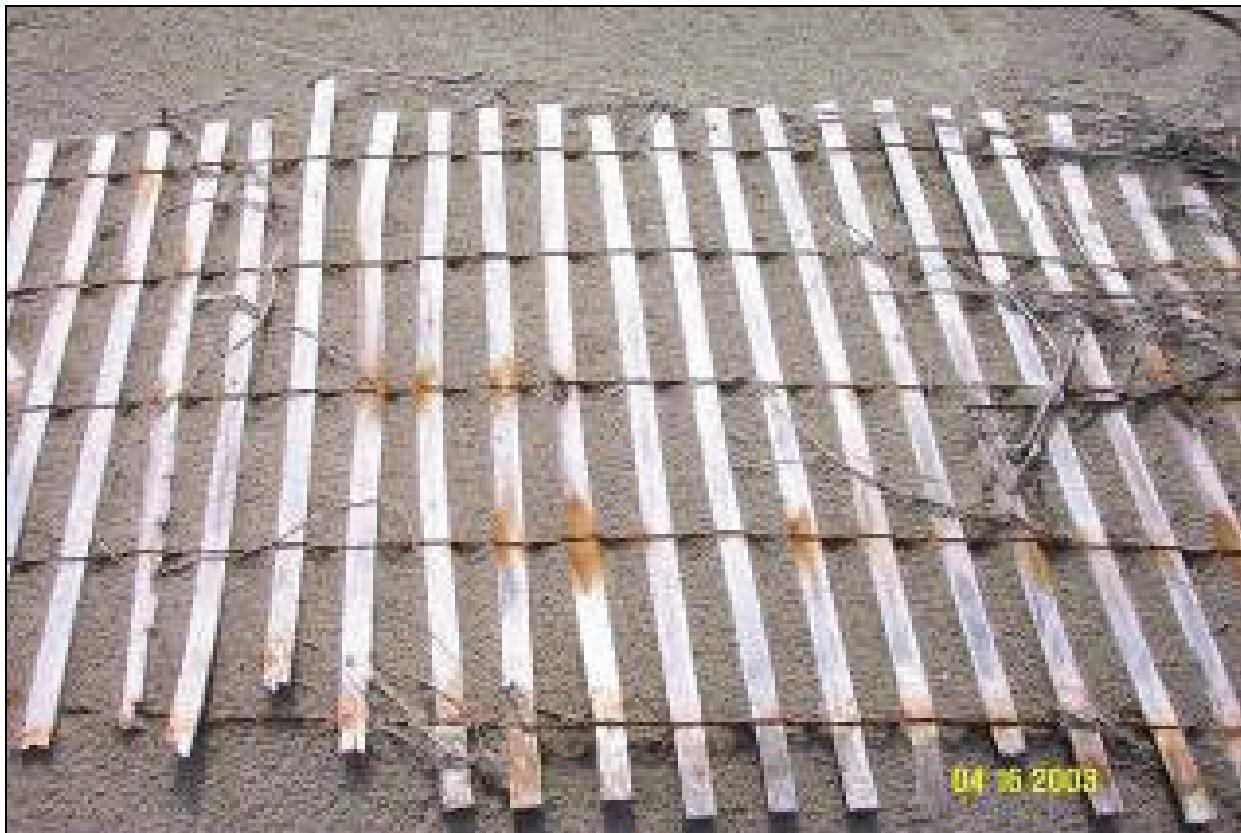
Figure 2. Sand fence nearly 3 years after installation; shrinkage and breaking of wooden slats have increased porosity through time.

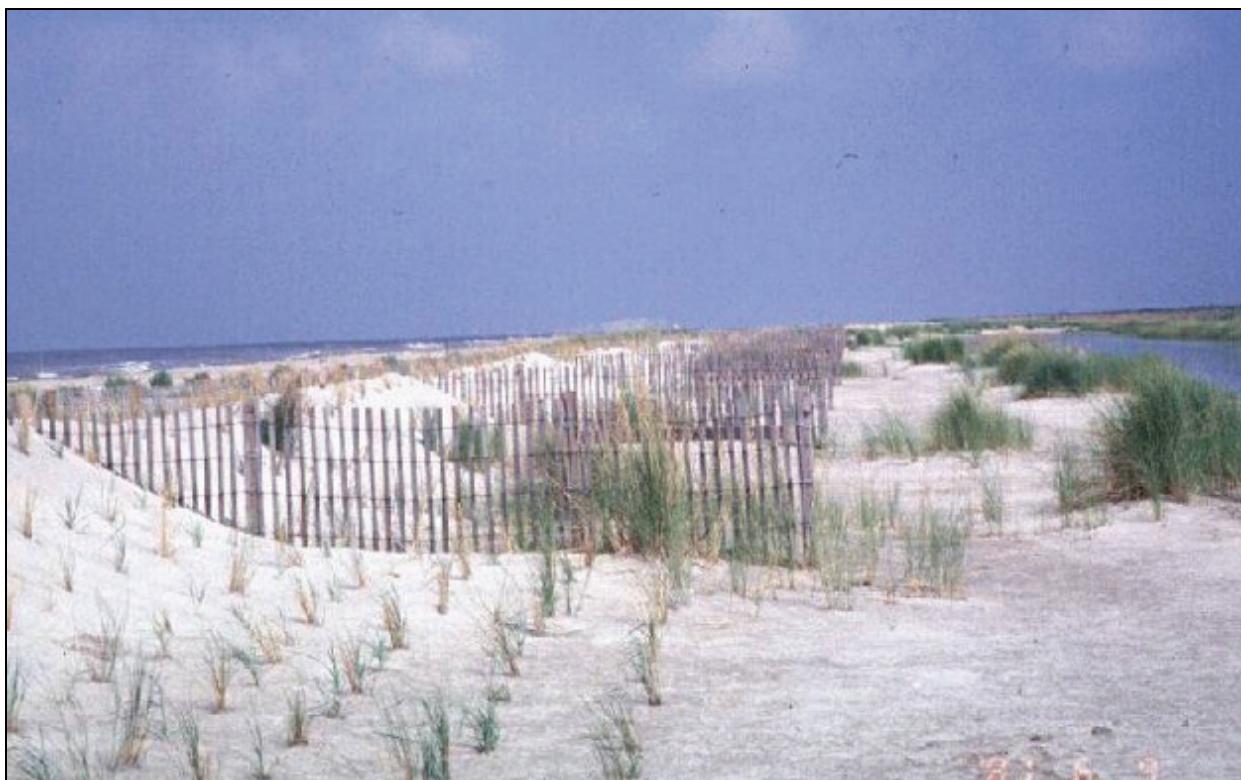
Figure 8. Sand fences (parallel to gulf shoreline) with perpendicular spurs (extending towards bay) at Timbalier Island Plantings Demonstration Project (Site A July 1996, looking northwest).

Based on observations at this site, Mendelssohn and Hester (1988) reported that sand fences with spurs accumulated more sand during the first year of construction compared to other designs tested. However, after 3 years, a straight fence design collected approximately 160 percent more sand than the fence with spurs (Mendelssohn and Hester 1988).

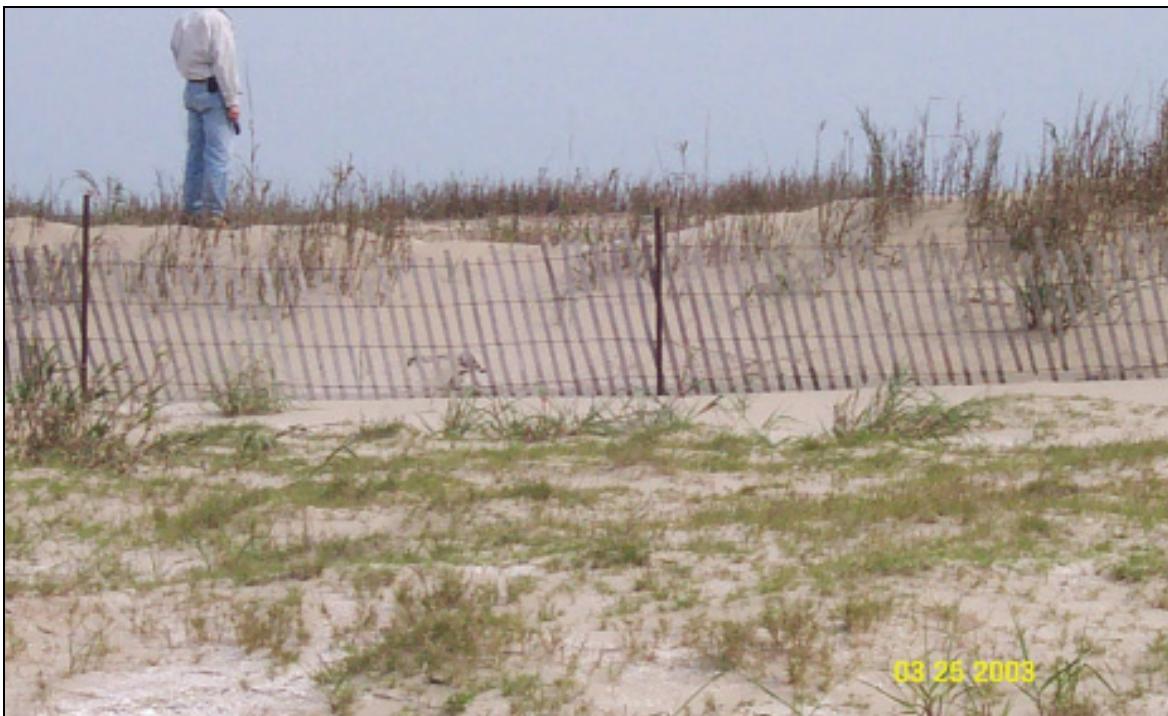
These fences trapped sand to create almost NE-SW trending dunes of higher relief (1.8-2.1 m). At places these dunes attained 2.5 m in relief (Figure 10). Thus, these fences were able to trap and redistribute the sediment in their lee side to form several parallel dunes.

Figure 10. Sand fence with dune created on East Island. Dune is on southeast side of fence indicating northerly winds moving sand and depositing on southeastern side.

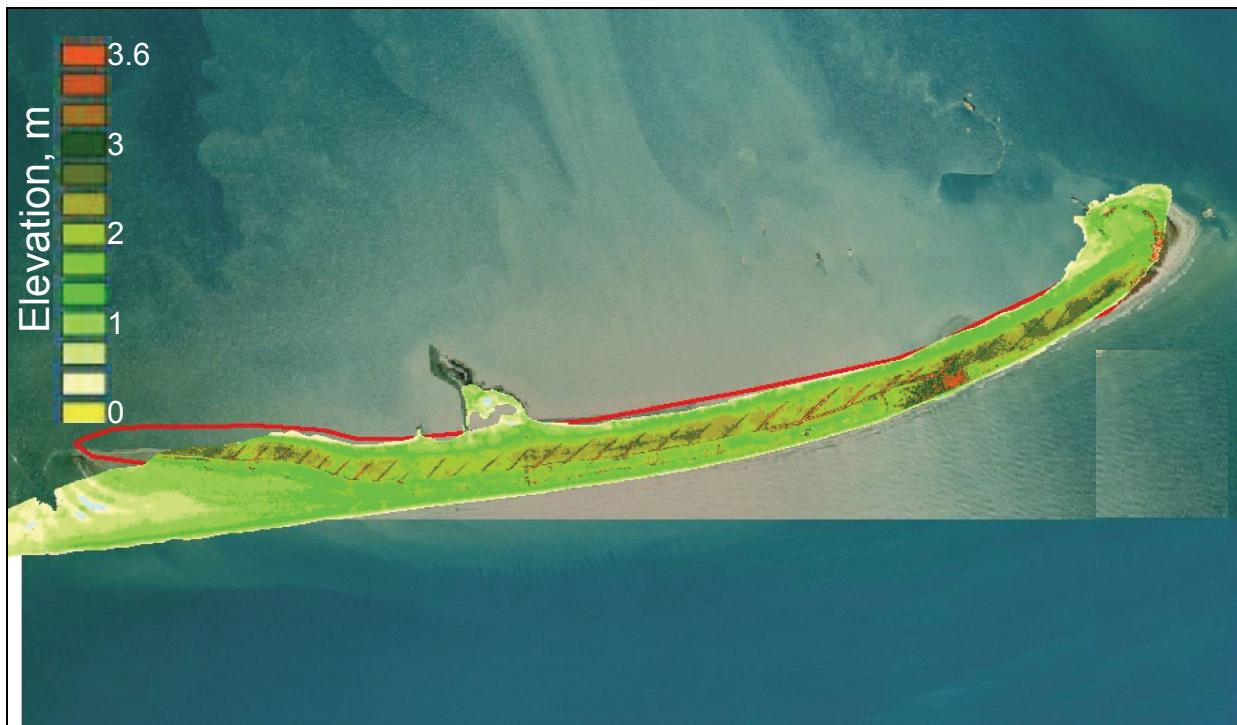
Formation of these dunes indicates the capability of sand fences in trapping and redistributing sand which otherwise would have been lost or eroded. LiDAR data showed an overall increase in the elevation of the island especially in the central portion where dunes were built by the fences (Figure 11).

Figure 11. LiDAR photograph indicating general elevation in East Island. Note central elevated portion with diagonal sand fences.

However, because the orientation of the sand fences was diagonal to the trend of the shoreline, the dunes formed in a morphology that tended to funnel water and create scour on the beach during overwash (Khalil and Lee 2004) (Figure 12).

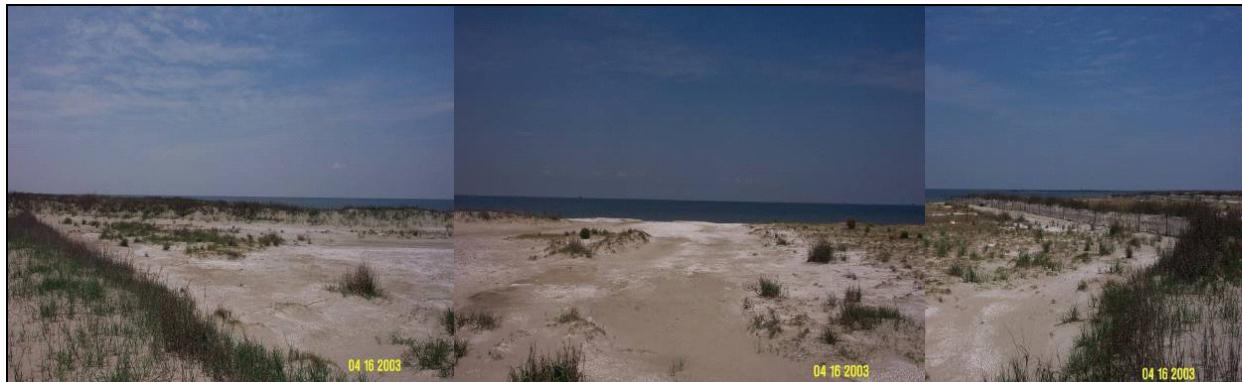
Figure 12. Scour between two dunes at East Island indicates focusing of water due to orientation of dunes.

The orientation of sand fences should maximize the retention of sand and its linear formation as shore-parallel dunes. If a sand fence is placed in a configuration that is not shore parallel, dunes that are formed will not be shore parallel, thus increasing the possibility of wave focusing and subsequent scour of the dune platform during storms. On the basis of observation of performance of sand fences on various barrier islands (Khalil and Lee 2004), it is recommended that the alignment of sand fences be shore parallel to maximize the stability of the dune platform during storms.

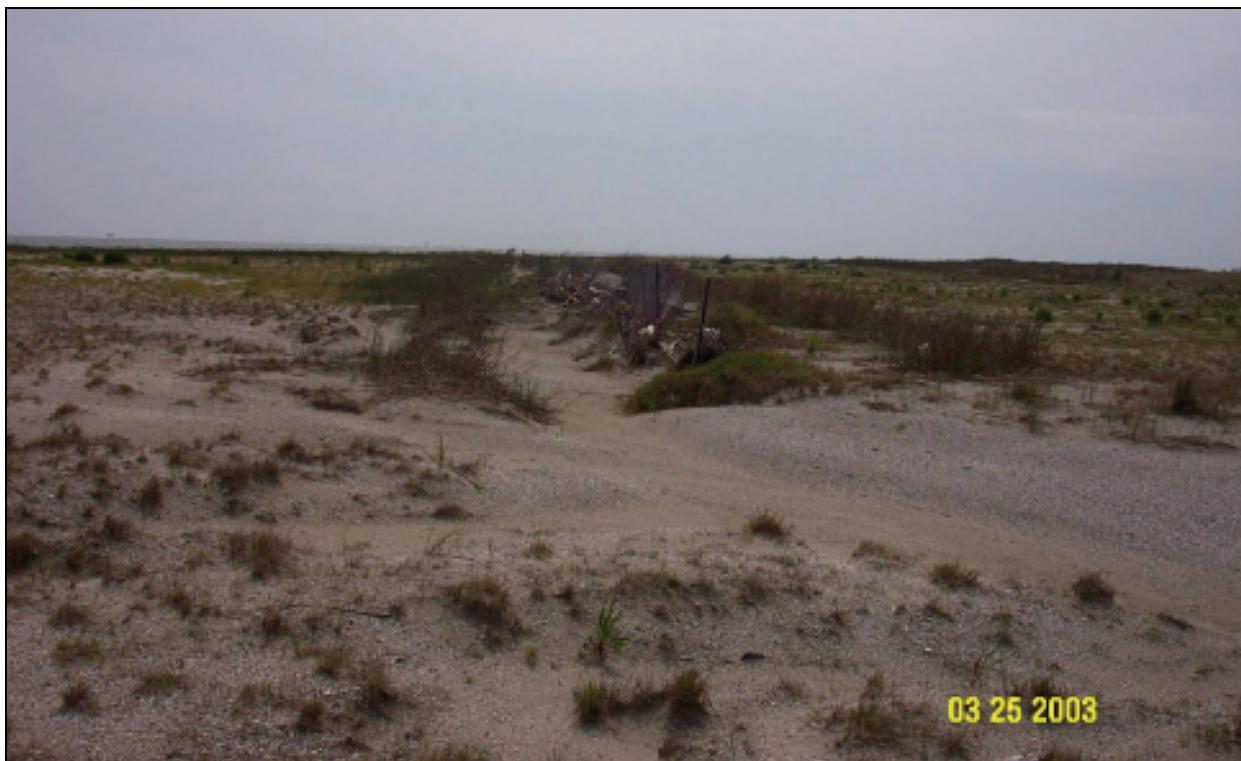
A similar phenomenon occurred on Trinity Island. The diagonal orientation of the sand fences and, ultimately, the dunes that formed funneled water in-between these relatively high-relief morphologic forms, created scour on the subaerial beach (Figure 14). In addition, dunes in this diagonal alignment will not function as levees to backshore areas nor will they provide a source of sediment for the foreshore.

Figure 14. Looking south on Trinity Island (note scour at rear of fence spur indicating focusing of water during overwash).

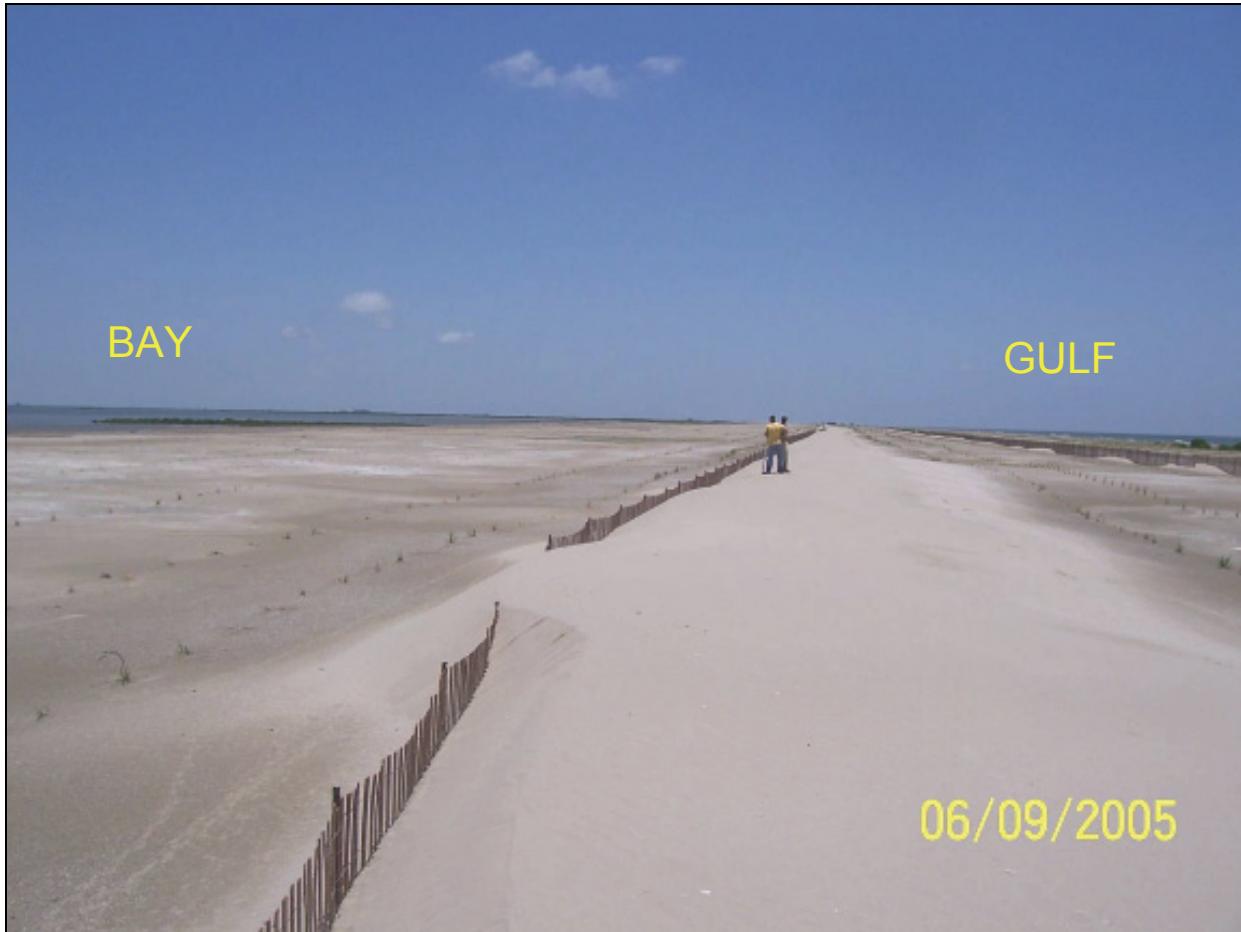
After observing the efficacy of sand fences on the Isle Dernieres projects, two rows of shore-parallel straight sand fences totaling approximately 10,600 m were installed immediately after the restoration of the island. These rows were 30 m apart. The fences trapped sand and built extensive dunes within a few months after their installation (Figure 16). The fences were installed in December 2004 and by April 2005 a dune higher than the fence had formed around the northern fence. The northern sand fence had accumulated more sand than the southern fence. Sand dunes were built on the lee (south) side of this northern fence, indicating the influence of the wind from the north. Sand accumulation was so great on the north fences that at places the dunes reached >1.5 m in elevation and overtopped the fences to the extent that the fences were completely buried. The dune-base built in the lee of the north fence ranged in average around 15 m in width and 1.7 m in height with a crest width of ~4 m. Because it was buried, the northern fence was no longer capable of trapping sand. The southern fence also trapped sand, but to a lesser degree. The average height of the dune was 0.6 m, located on both sides of the fence. The

width of the base of the dune ranged from 7.5 to 9 m and the crest width averaged 3 m. Obviously, the northern fence performed better and trapped more sand.

Figure 16. Looking east, formation of dunes towards south of northern sand fence at Timbalier Island.

It appears that the southern fence could not perform well because of the presence of northern fence. The sediment supply for the southern fence from the north was restricted by the presence of the northern sand fence and dunes that formed. This reaffirms the conclusion that wind capable of transporting sand on Louisiana islands during nonsaturated conditions is from north to south (or northeast to southwest).

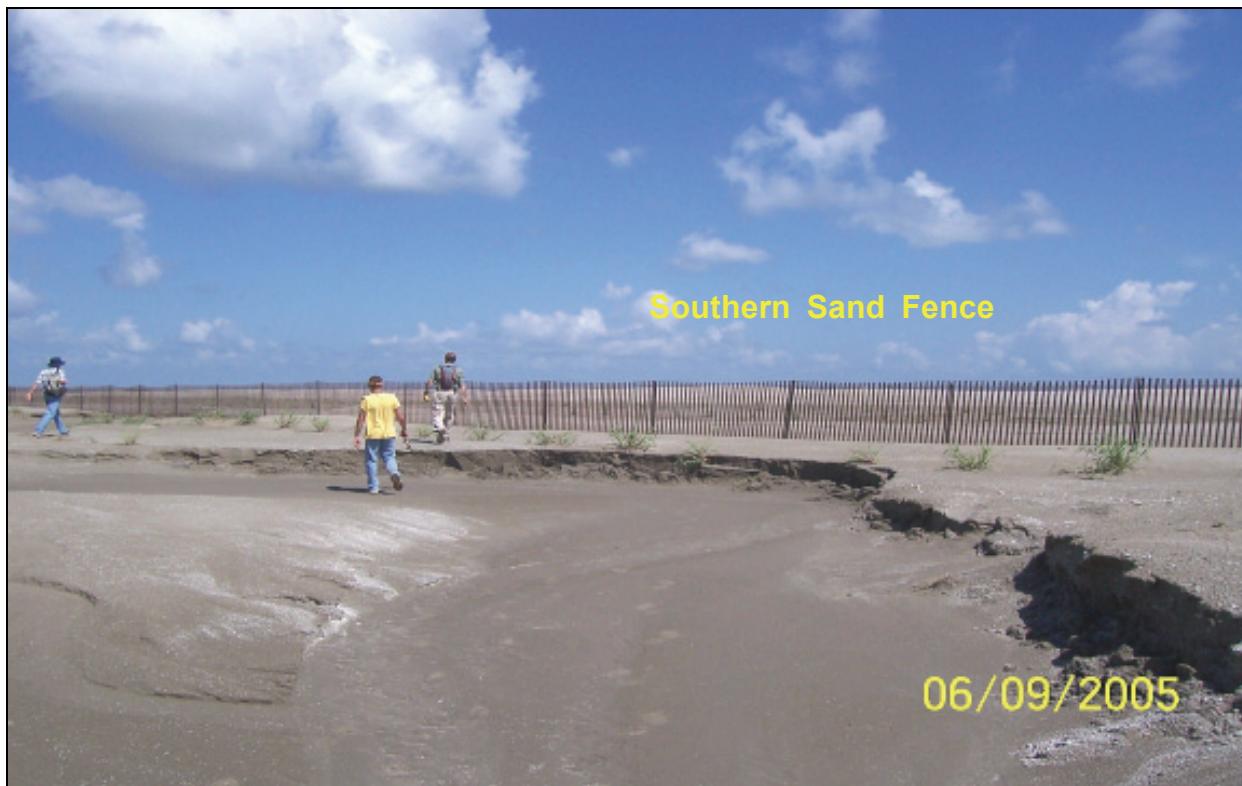
Because of the difference in elevation of the two adjacent dunes, rainwater accumulated within the trough of the two dunes and flowed gulfward, towards the southern dune, which was lower in elevation. This flow created three breaches in the southern dune as well on the beach-berm (Figure 17). If the sand fences had instead been installed sequentially, then the development of a swale between dunes could have been avoided. Sequencing of fences is necessary if more than one sand fence will be installed. The distance between rows of fencing should not exceed more than four times the height of the fence (Savage 1963), which in this case would be 4.8 m. For Louisiana, fences should be installed in sequence starting from gulf side to build larger foredunes on the gulf side of the island.

Figure 17. Rainwater that accumulated between dunes flowed towards gulf through southern dunes, which was lower in elevation, creating breaching in dune and on beach berm (looking north).
